Corrosion in Fuel Systems

ULSD Issues

NORA Research Technical Workshop
September 15, 2016 Newport, RI

Wayne Geyer
Steel Tank Institute

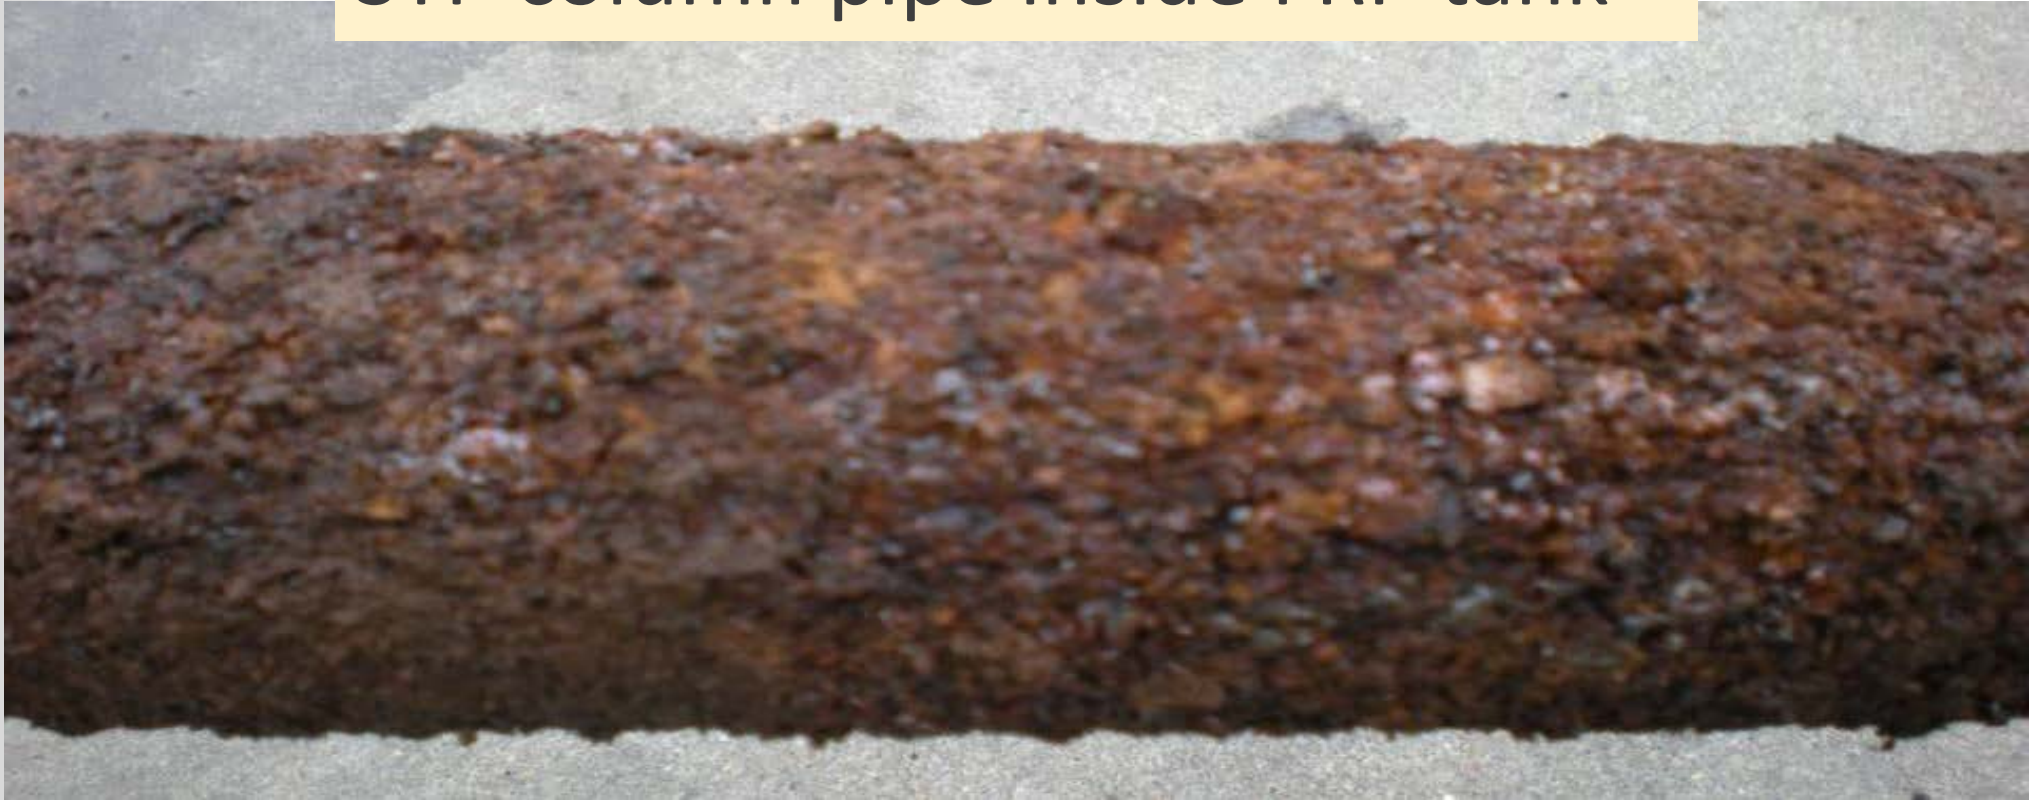
STP column pipe inside FRP tank

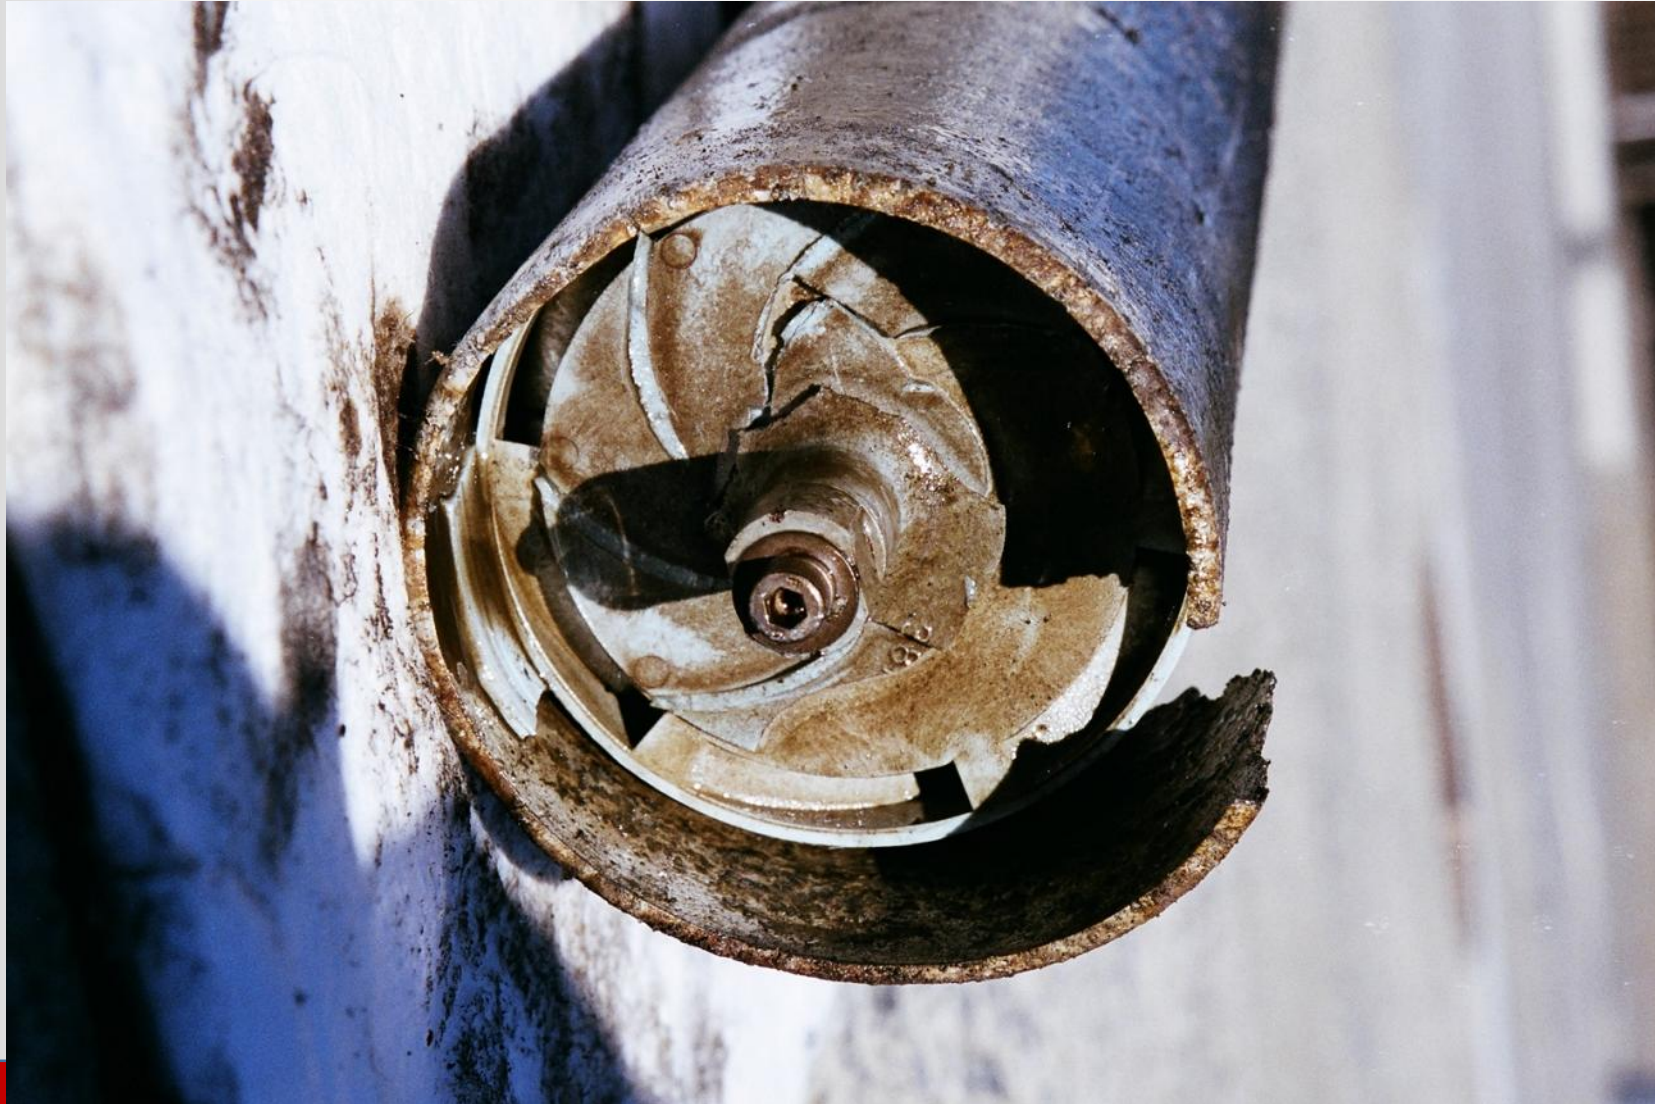
In service less than one year
STP Column Pipe

Pump connection corroded thru

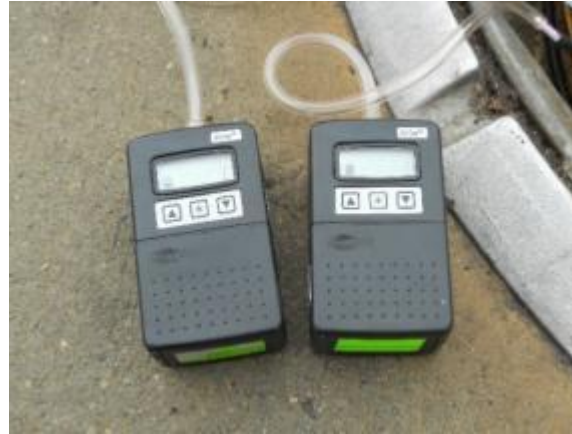
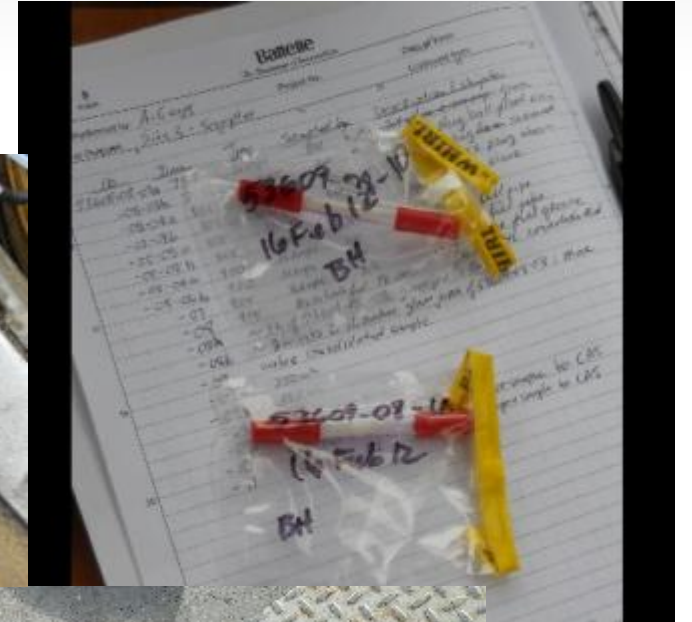
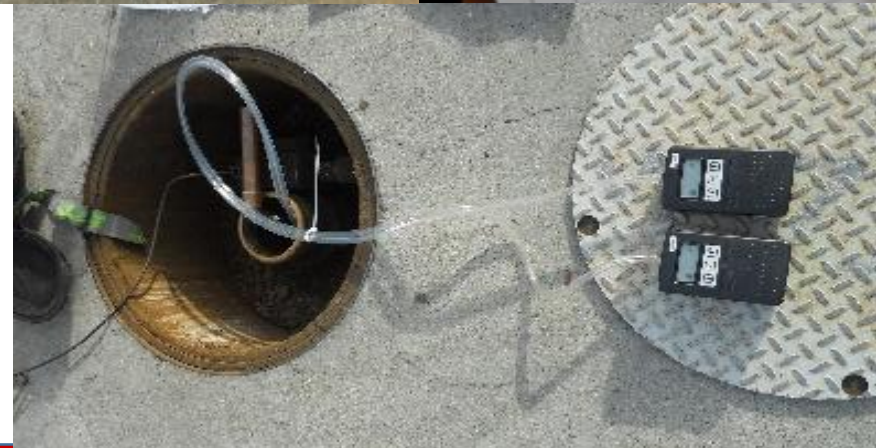
Vapor Sampling: SKC Tubes

- Tested for carboxylic acids and formic acid analysis by GC-MS (CAS Method 102)

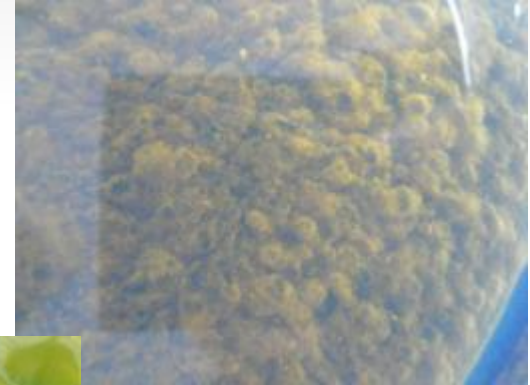
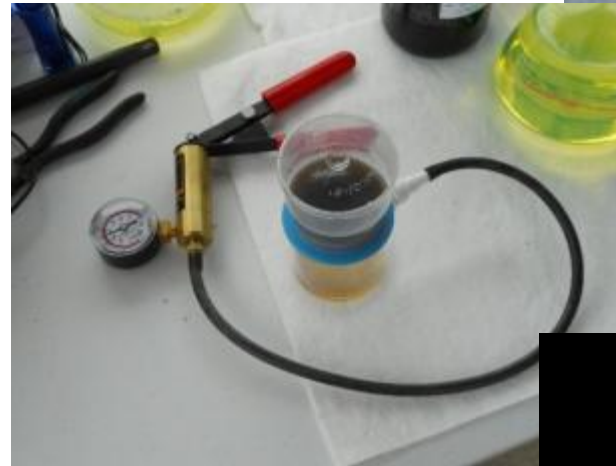
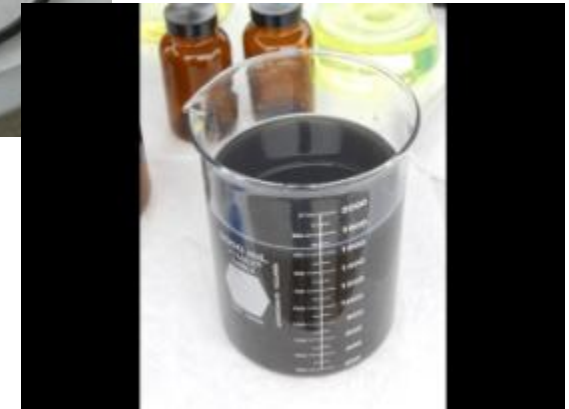
Water Bottom Sampling

- ~1-2 Liters of water bottom sample/site
- Bottom sediment
- Consolidated from multiple risers
- Bacon Bomb triggered by bottom of tank

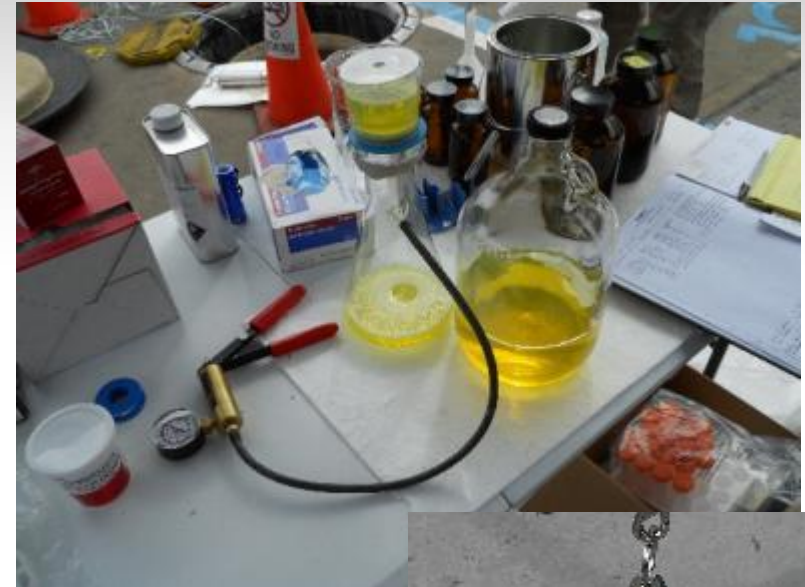
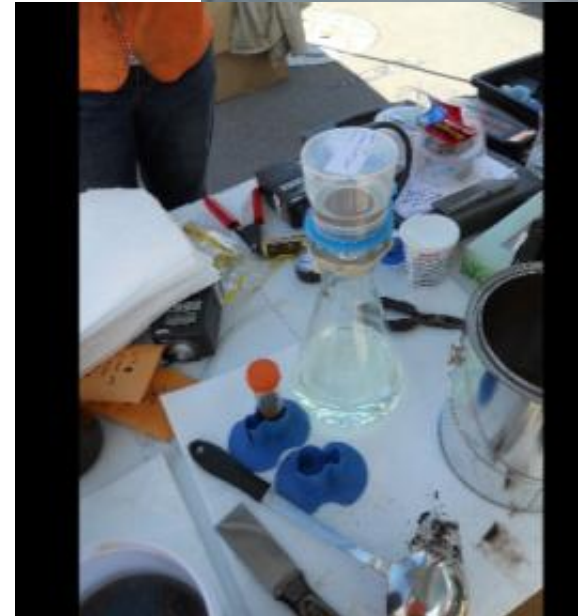
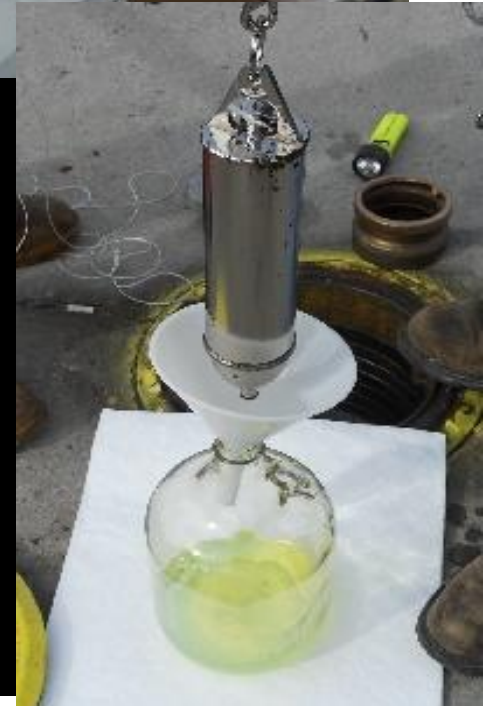
Inspection Process Fuel Sampling

- 1 gallon of diesel sample/site
- Consolidated from multiple risers
- Bacon Bomb with string to trigger collection within fuel column

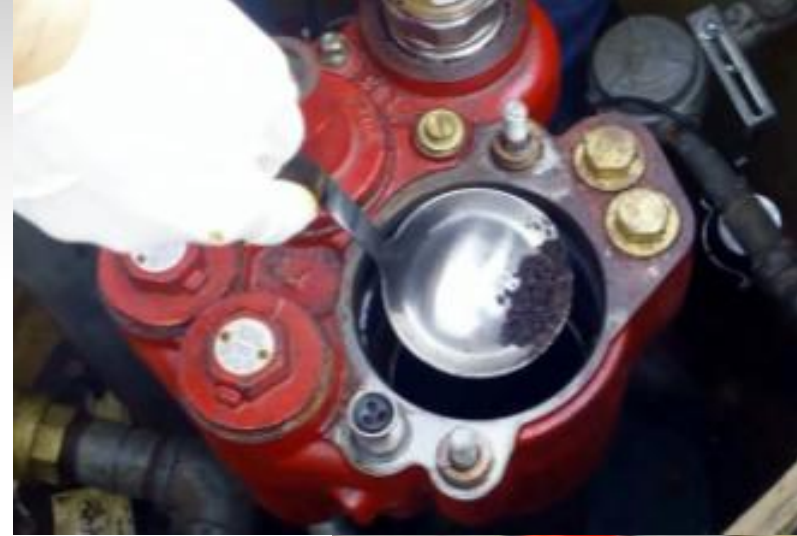
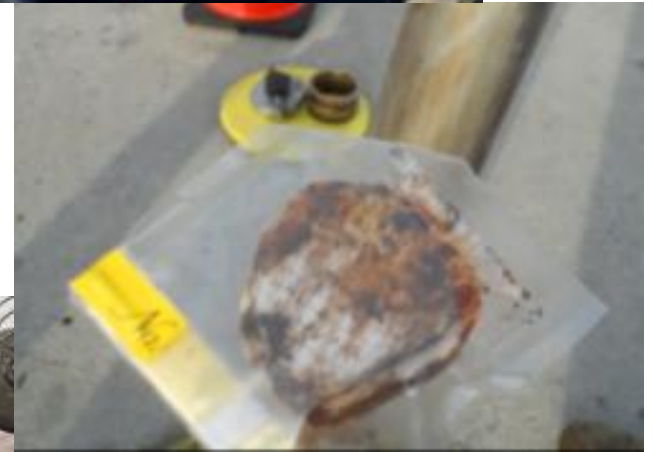
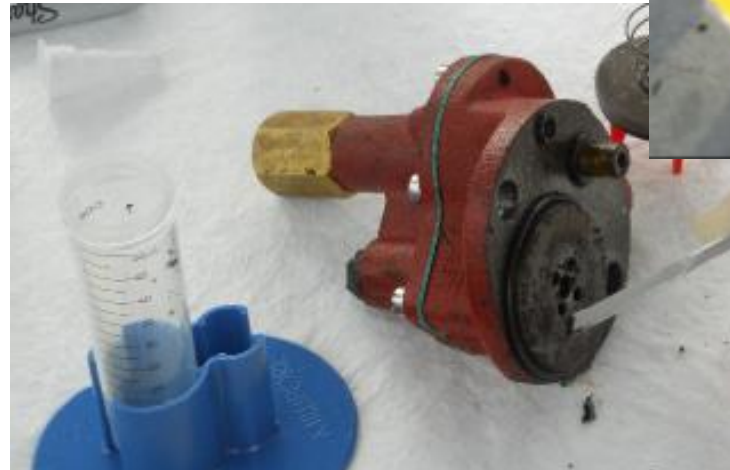
Inspection Process Disassembled System

- Collected scrape, wipe, o-rings, and other corrosion samples
- Fouling investigation process by 2 labs

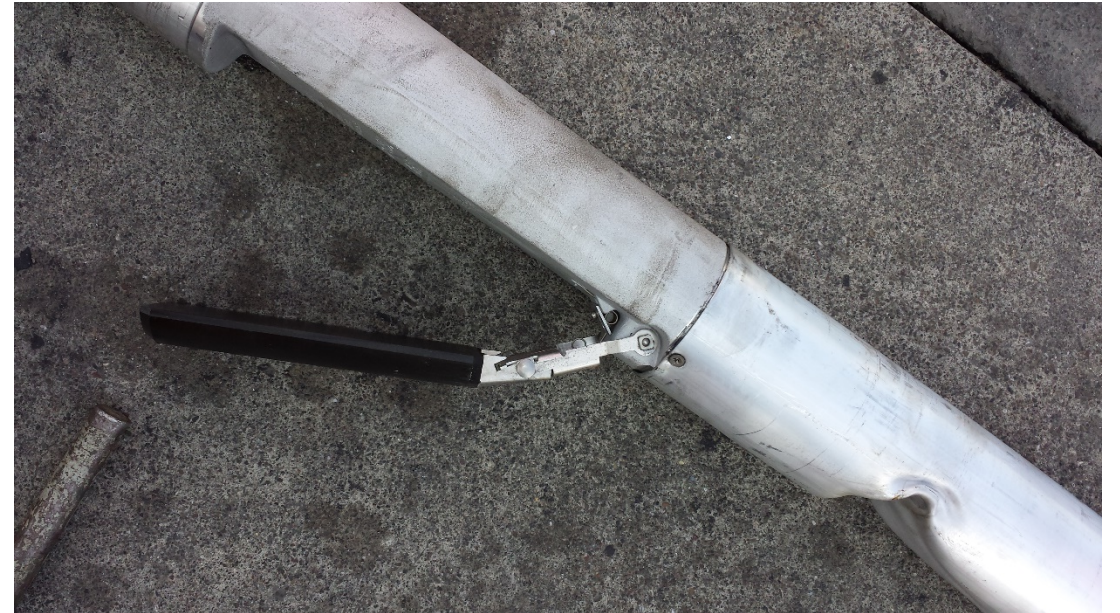
Equipment Analysis

- If equipment was removed, it was visually examined and photographed
- Pristine condition!
