B20 to B100 Blends as Heating Fuels

Brookhaven National Laboratory

The following is an excerpt from *B20 to B100 Blends as Heating Fuels*, released November 2018

Evaluation of Oil Burner Pumps Under Operating Conditions

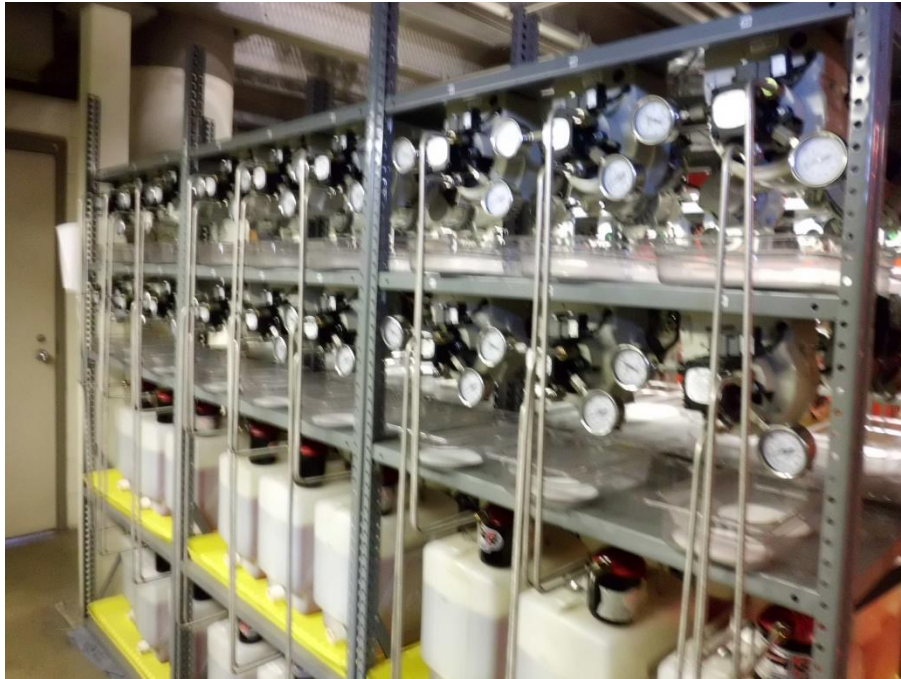
Figure 0-1 Pumps under test at Penn State University

Under the test conditions, all pumps were found to leak very slightly. In an analysis of the results using success criteria provided by the manufacturer, it was found that the pumps with biodiesel had lower leak rates over the course of the test than did the pumps without biodiesel.

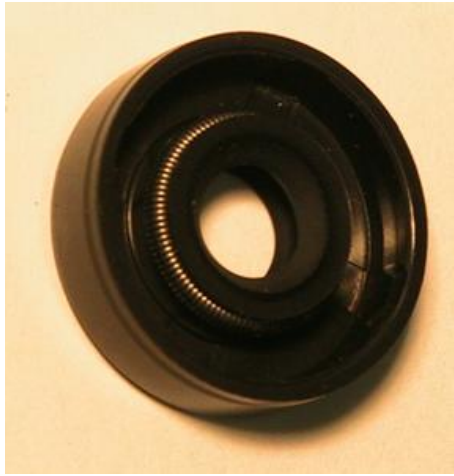
Figure 0-4 Photo of a new oil pump shaft seal.

As with the lab long term run studies, the focus of this inspection has been on the lip-style shaft seal. Figure 2-4 provides a photo of this seal. Figure 2-5 is a sketch of the seal and Figure 2-6 shows a low magnification microscope image of the sealing edge of a new seal.

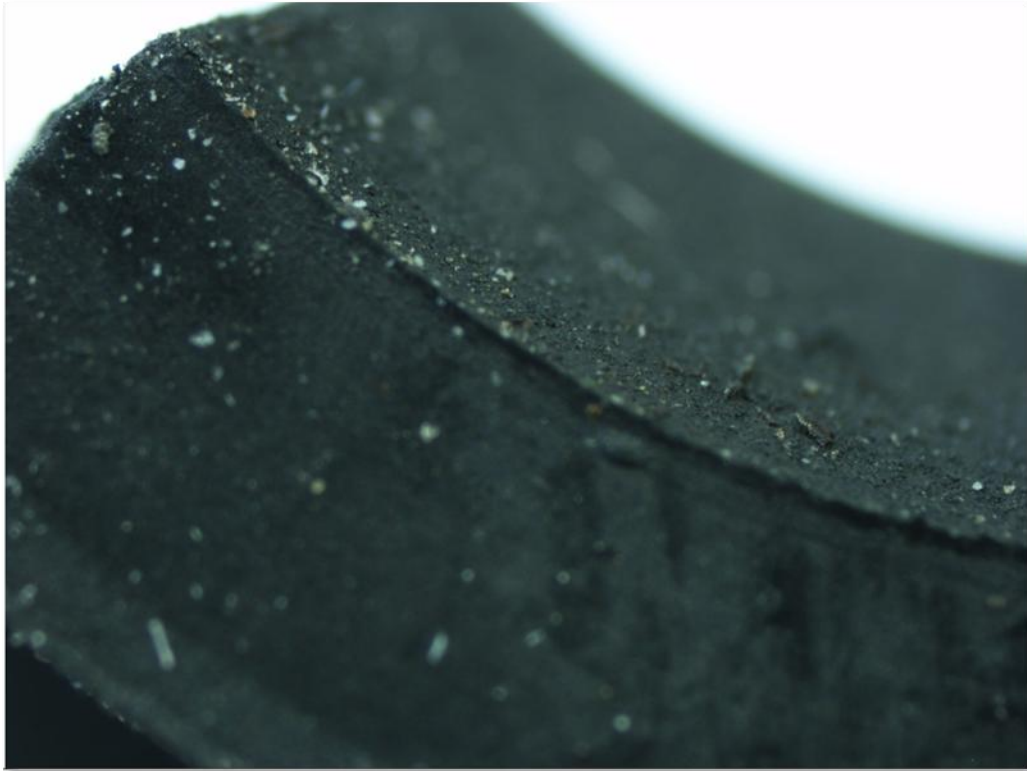
Figure 2-8 shows the edge of a seal from a pump which had been using B100 for 6 months in the field. Again, there is no significant sign of damage to the sealing edge.

Figure 0-8 Image of the sealing edge of a shaft seal from a pump after six months of field operation on B100.
